# New Hampshire Volunteer Lake Assessment Program

## 2002 Bi-Annual Report for Mascoma Lake Enfield

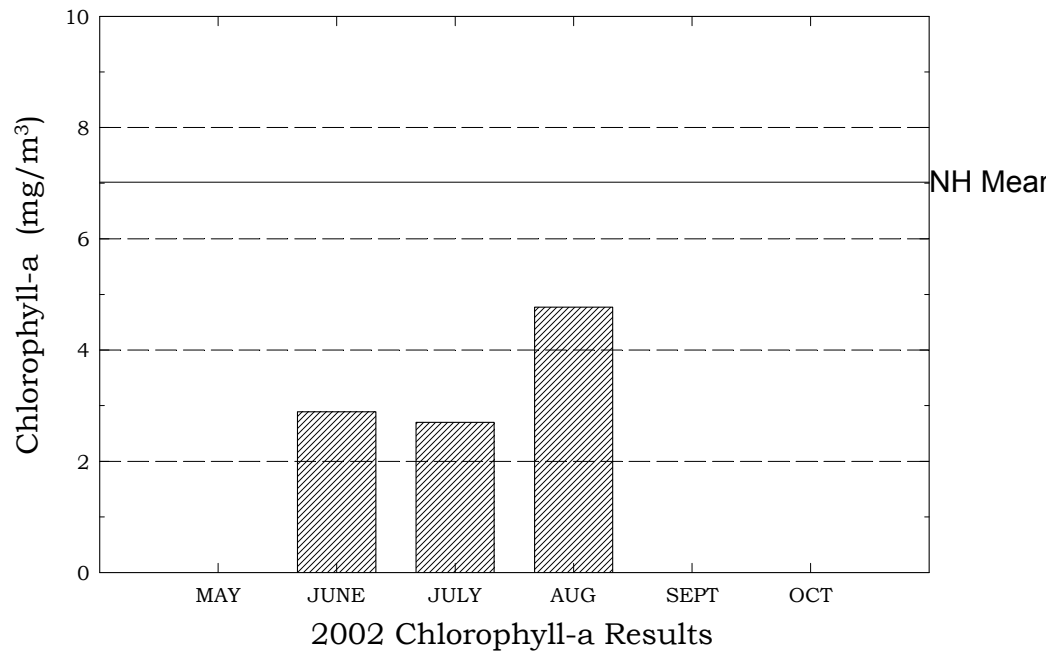
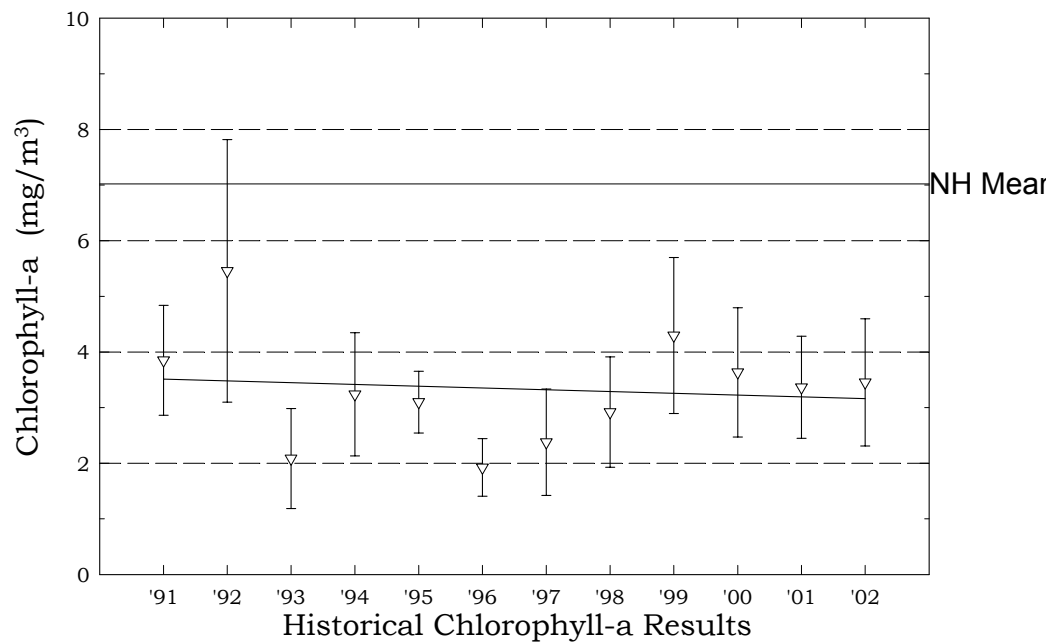
**Figure 1.** Monthly and Historical Chlorophyll-a Results

The current year data (the top graph) show that the chlorophyll-a concentration **decreased very slightly** from June to July, and then **increased** from July to August.

The historical data (the bottom graph) show that the 2002 chlorophyll-a mean is **less than** the state mean.

Overall, the statistical analysis of the historical data (the bottom graph) shows that the mean annual chlorophyll-a concentration has **not significantly changed** since monitoring began in **1991**. Specifically, the chlorophyll-a concentration has **fluctuated**, but has not *continually increased* or *decreased* since monitoring began. (Note: Please refer to Appendix E for the detailed statistical analysis explanation and data print out.) It is worthy to note that the mean annual chlorophyll-a concentration has been **less than** the state median since monitoring began. We hope this continues!

- **Figure 1 and Table 1:** The graphs in Figure 1 (Appendix A) show the historical and current year chlorophyll-a concentration in the water column. Table 1 (Appendix B) lists the maximum, minimum, and

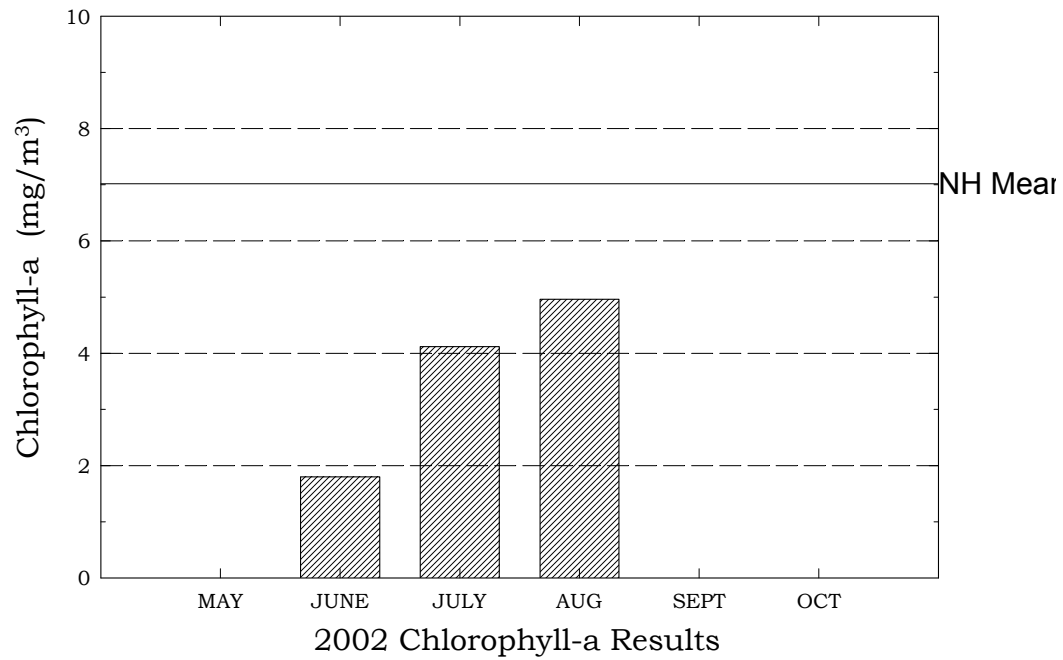
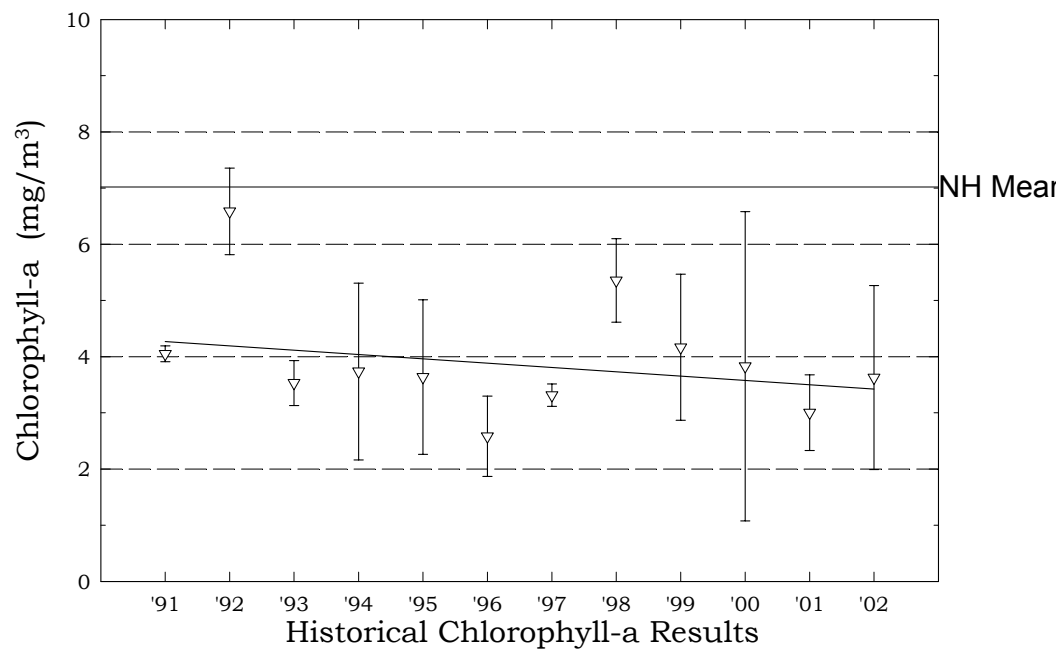
**Figure 1.** Monthly and Historical Chlorophyll-a Results

The current year data (the top graph) show that the chlorophyll-a concentration **increased gradually** from June to August.

The historical data (the bottom graph) show that the 2002 chlorophyll-a mean is **less than** the state mean.

Overall, the statistical analysis of the historical data (the bottom graph) shows that the mean annual chlorophyll-a concentration has **not significantly changed** (either *continually increased* or *decreased*) since monitoring began in **1991**. Specifically, the chlorophyll-a concentration has **fluctuated** since monitoring began. (Note: Please refer to Appendix E for the detailed statistical analysis explanation and data print out.)

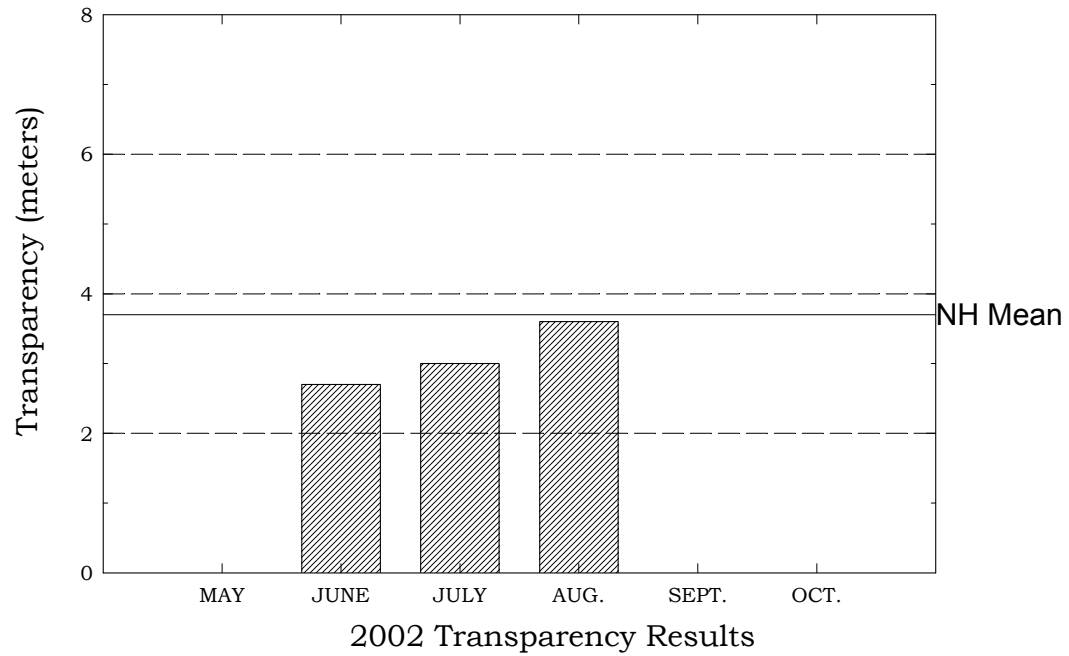
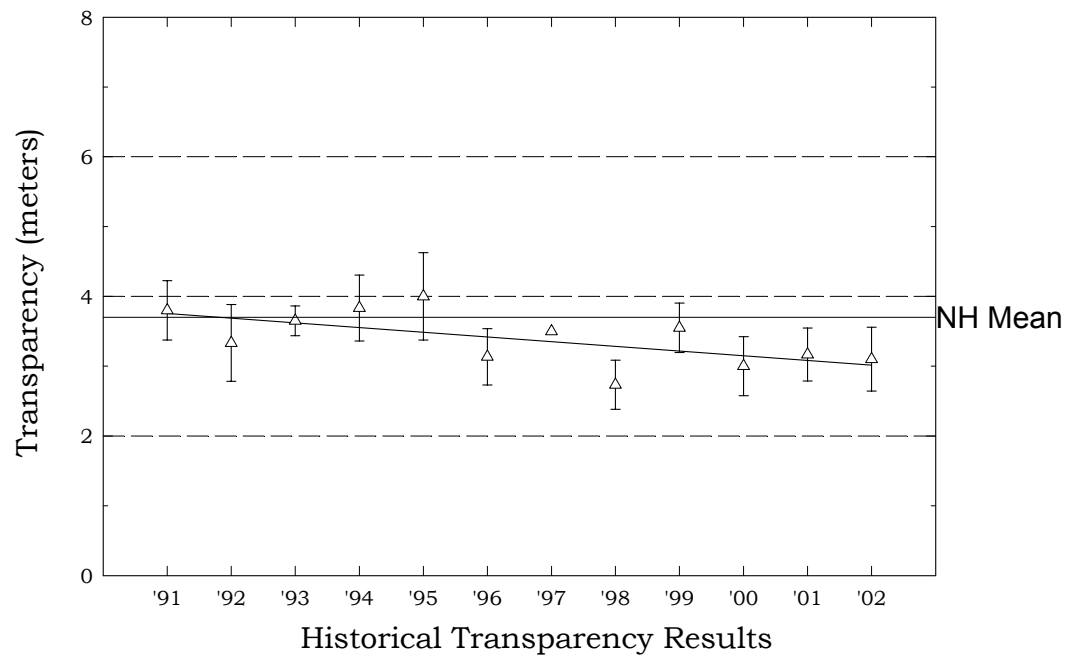
**Figure 2.** Monthly and Historical Transparency Results

The current year data (the top graph) show that the in-lake transparency **increased gradually** from June to August.

The historical data (the bottom graph) show that the 2002 mean transparency is **slightly less than** the state mean.

Overall, the statistical analysis of the historical data show that the transparency has **significantly decreased** since monitoring began. Specifically, the in-lake transparency has **decreased** (meaning **worsened**) at this station on average by **approximately 1.9 percent** per sampling season during the sampling period **1991 to 2002**. (Note: Please refer to Appendix E for the statistical analysis explanation and data print out.)

- **Figure 2 and Table 3:** The graphs in Figure 2 (Appendix A) show historical and current year data for lake/pond transparency. Table 3 lists the maximum, minimum and mean transparency data for each sampling season that the lake/pond has been monitored through the program.

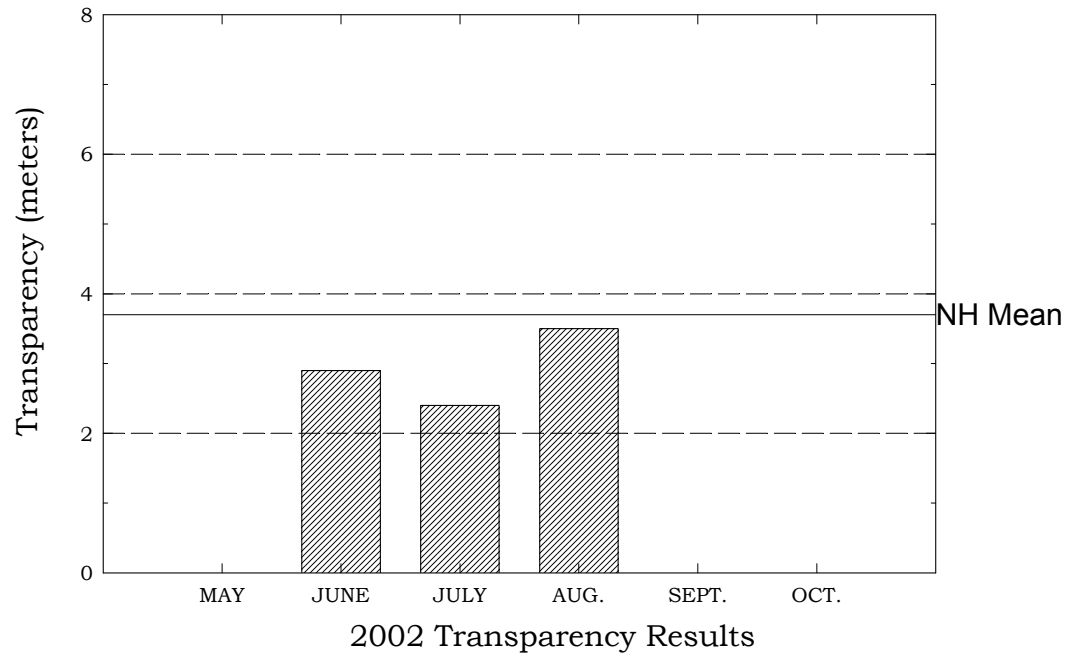
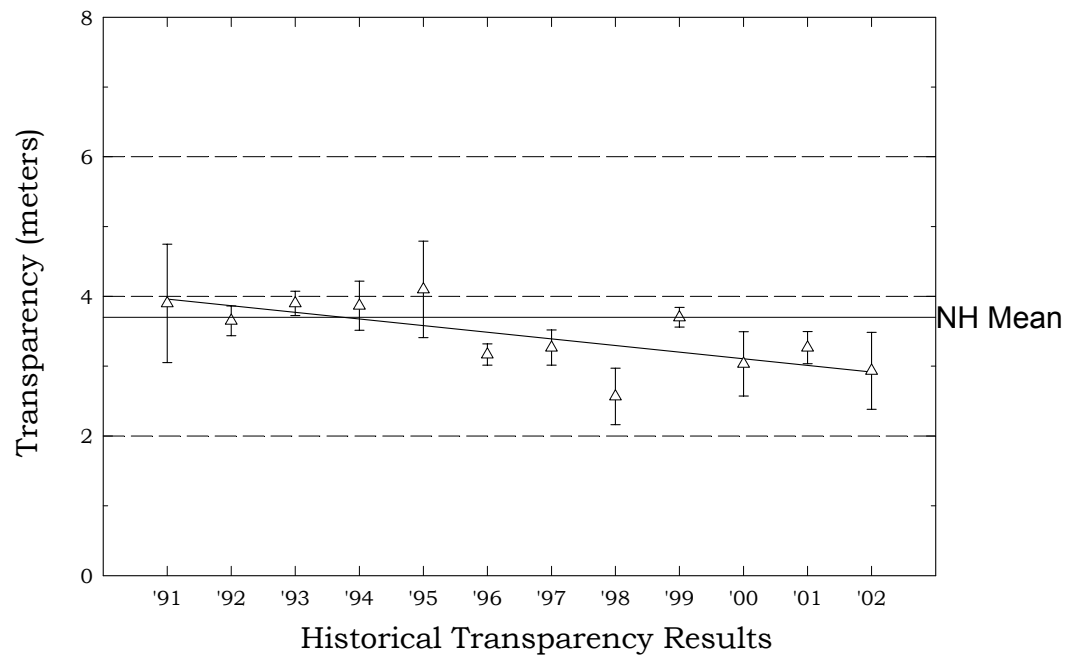
**Figure 2.** Monthly and Historical Transparency Results

The current year data (the top graph) show that the in-lake transparency **decreased** from June to July, and then **increased** from July to August.

The historical data (the bottom graph) show that the 2002 mean transparency is **less than** the state mean.

Overall, the statistical analysis of the historical data show that the transparency has **significantly decreased** since monitoring began. Specifically, the in-lake transparency at this station has **decreased** (meaning **worsened**) on average by **approximately 2.6 percent** per sampling season during the sampling period **1991 to 2002**. (Note: Please refer to Appendix E for the statistical analysis explanation and data print out.)

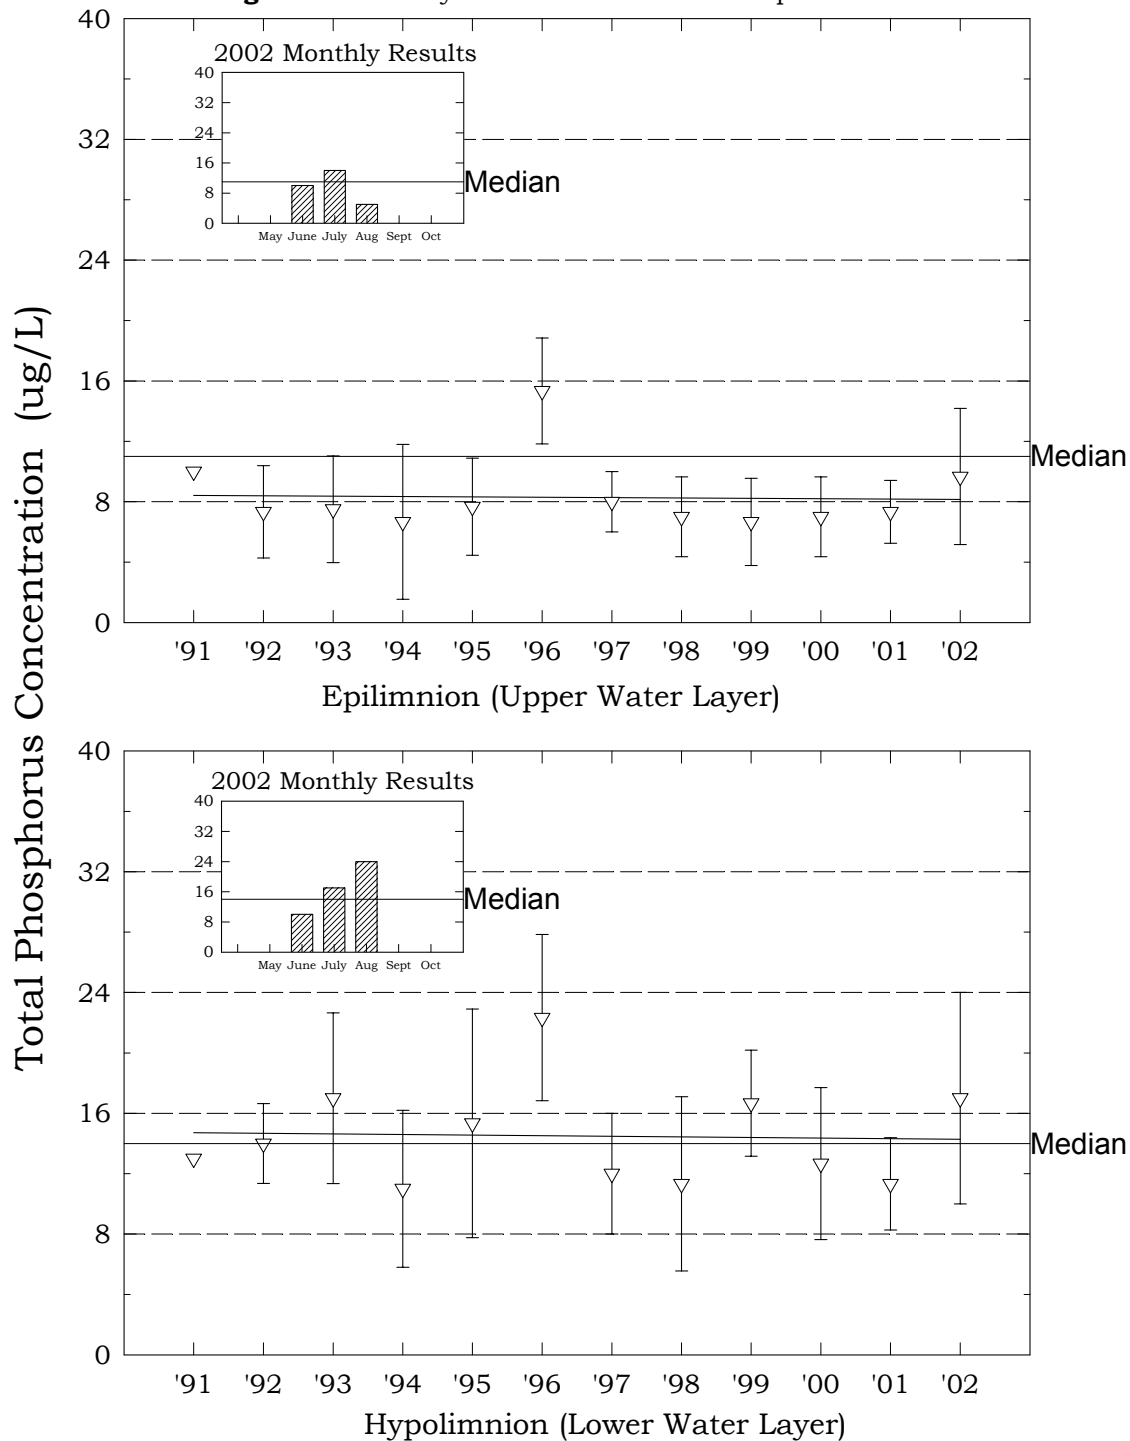
**Figure 3.** Monthly and Historical Total Phosphorus Data.

The current year data for the epilimnion (the top inset graph) show that the total phosphorus concentration **increased** from June to July, and then **decreased** from July to August. The total phosphorus concentration in July was **greater than** the state median.

The historical data show that the 2002 mean epilimnetic total phosphorus concentration is **slightly less than** the state median.

The current year data for the hypolimnion (the bottom inset graph) show that the total phosphorus concentration **increased steadily** from June to August. The total phosphorus concentration in July and August was **greater than** the state median.

It is important to note that the turbidity of the hypolimnion (lower layer) sample was elevated on the **August** sampling event (6.7 NTUs). This suggests that the lake/pond bottom may have been disturbed by the anchor or by the Kemmerer Bottle while sampling. When the lake/pond bottom is disturbed, sediment, which typically contains attached phosphorus, is released into the water column. When collecting the hypolimnion sample, please check to make sure that there is no sediment in the Kemmerer Bottle before filling the sample bottles.

The historical data show that the 2002 mean hypolimnetic total phosphorus concentration is **slightly greater than** the state median.

Overall, the statistical analysis of the historical data show that the total phosphorus concentration in the epilimnion (upper layer) and the hypolimnion (lower layer) has **not significantly changed** (either *increased* or *decreased*) since monitoring began. Specifically, the total phosphorus concentration in the epilimnion has remained **relatively stable** and has been generally **less than** the state median since monitoring began in 1991. The total phosphorus concentration in the hypolimnion has **fluctuated**, but has not *continually increased* or *decreased* since monitoring began. (Note: Please refer to Appendix E for the statistical analysis explanation and data print out.)

- **Figure 3 and Table 8:** The graphs in Figure 3 (Appendix A) show the amounts of phosphorus in the epilimnion (the upper layer) and the hypolimnion (the lower layer); the inset graphs show current year data. Table 8 (Appendix B) lists the annual maximum, minimum, and median concentration for each deep spot layer and each tributary since the lake/pond has joined the program.

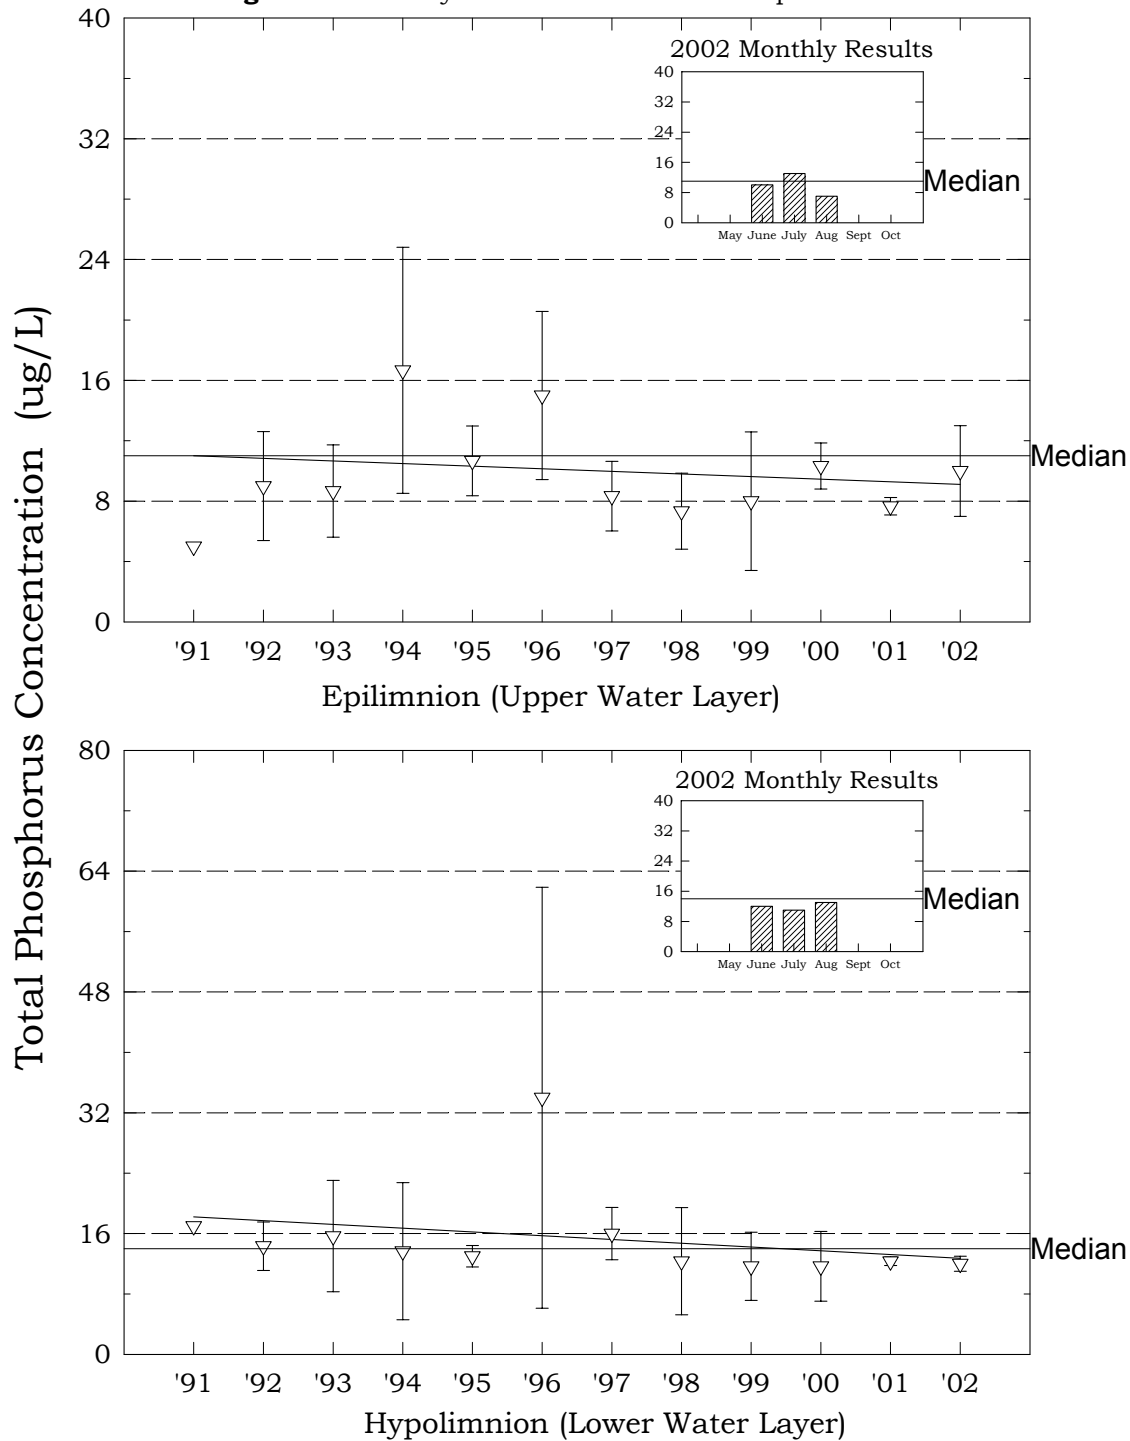
**Figure 3.** Monthly and Historical Total Phosphorus Data.

The current year data for the epilimnion (the top inset graph) show that the total phosphorus concentration **increased slightly** from

June to July, and then **decreased** from July to August. The total phosphorus concentration in July was **slightly greater than** the state median.

The current year data for the hypolimnion (the bottom inset graph) show that the total phosphorus concentration **decreased very slightly** from June to July, and then **increased slightly** from July to August.

The historical data show that the 2002 mean epilimnetic and hypolimnetic total phosphorus concentration is **slightly less than** the state median.

Overall, the statistical analysis of the historical data show that the total phosphorus concentration in the epilimnion (upper layer) and the hypolimnion (lower layer) has **not significantly changed** (either *increased* or *decreased*) since monitoring began. Specifically, the total phosphorus concentration in the epilimnion and the hypolimnion has **fluctuated**, but has not *continually increased* or *decreased* since monitoring began in 1991. (Note: Please refer to Appendix E for the statistical analysis explanation and data print out.)
